Re: Request for Sanctioning of Lubrication Tests

PROPOSAL OF TESTING OF MULTI—PURPOSE LUBRICANT  
CAMTRON 4039 SPECIAL APPLICATION SYNTHETIC OIL  
7 SEPTEMBER 1983

The cooling fan assembly in these vehicles experiences a higher failure rate than would seem normal for such a mechanical assembly. This has led to a disproportionate recurrence of Not Mission Capable (NNC) ratings resulting from failure.

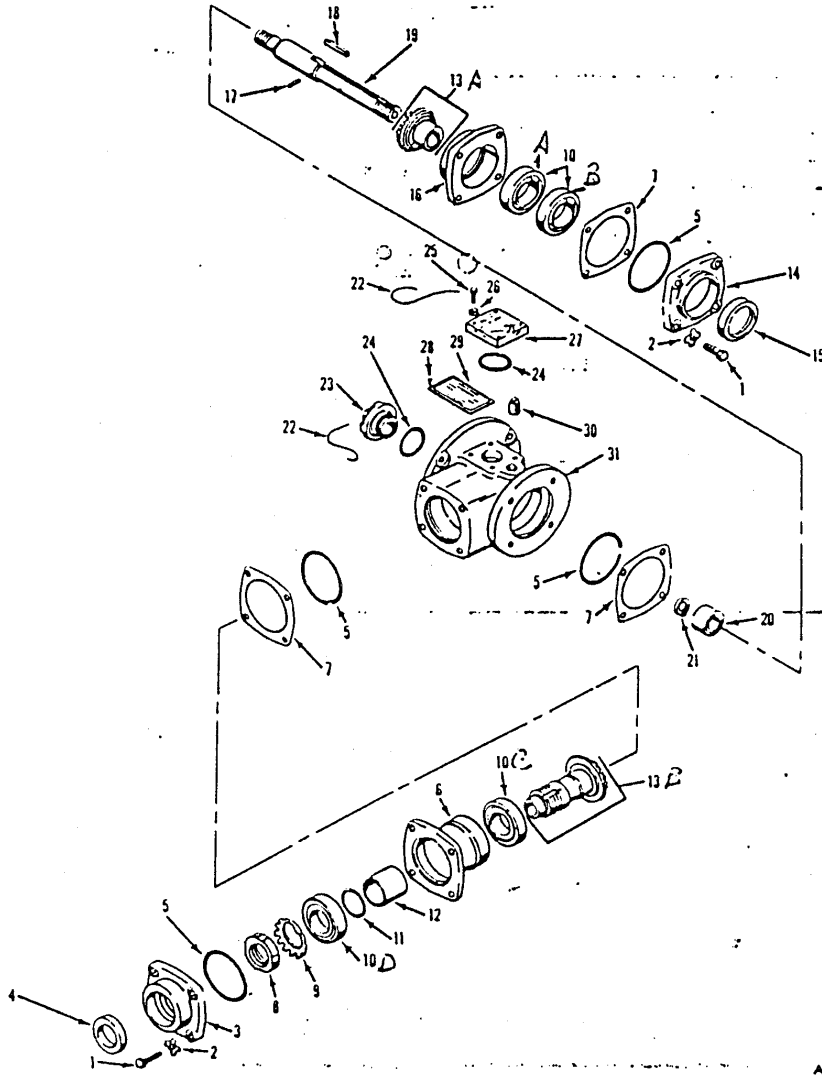
The failures most frequently occur in the bearings captioned as 10A—10B—10C—10D in the exploded diagram (appendix II). Deterioration of gears 13A and 13B occurs in concert with the bearing failure. When these failures occur, the results can range from cessation of movement of the impeller to total disintegration of the gear assembly.

Figure 1. Cooling fan angle drive assembly.

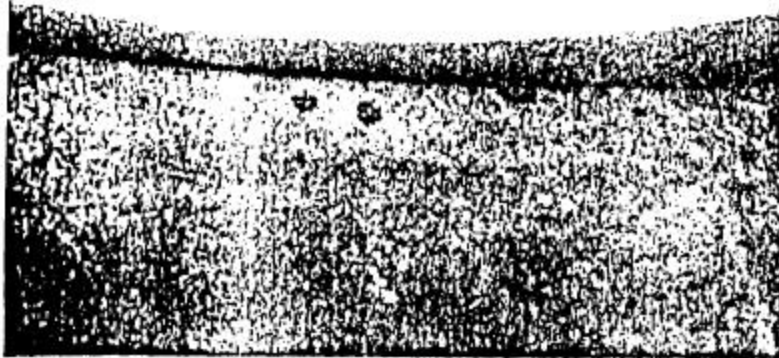
In the inspection of Unit #2, the first feature to be noted is the scoring of the inner diameter of the fan tower. This is shown in Appendix V, Figure 1. It was this scoring which led to the cessation of testing on unit #2 at 37:48:52 of Phase I. This scoring underlined the potential for extensive damage in the event of lubrication failure leading to disintegration of the unit.

This is the inner diameter of the untreated fan tower.

The scoring of the housing resulting from the failure of the bearing shown in Appendix VI Fig 2 & 4.

This resulted in the unit being declared 'unserviceable' when only a small band had appeared. Most of this scoring was sustained in the Phase II portion of the testing.

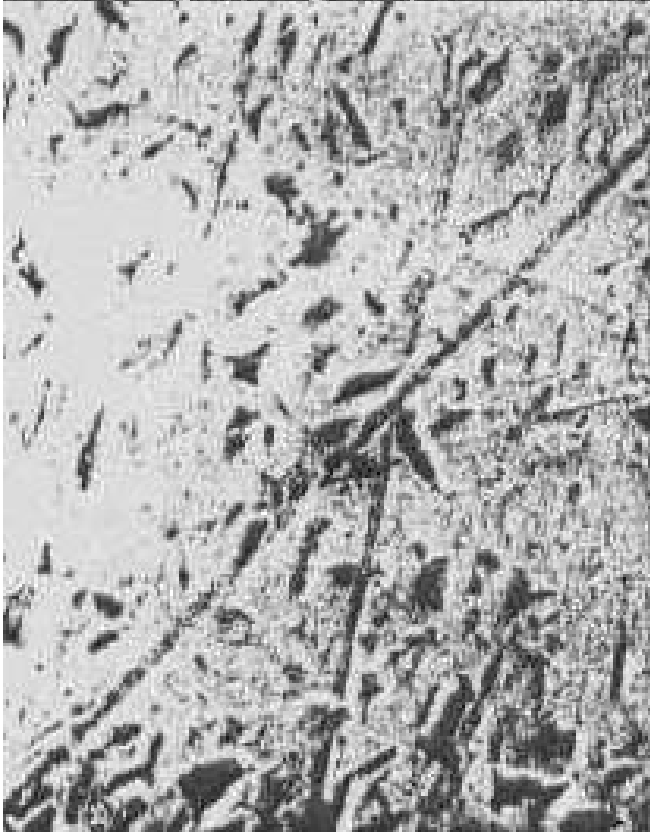
##### Ball bearing from Untreated Unit (Fig 2)

This ball surface shows considerable wear. There is evidence of primary brineeling, skidding or spalling.

In spite of the fact that the ball wears the least (in comparison with the race) this ball does show that it has been wearing.

Wear of this nature is generally the result of inadequate lubrication. It is discussed in more detail in the Evaluation Section of this report.

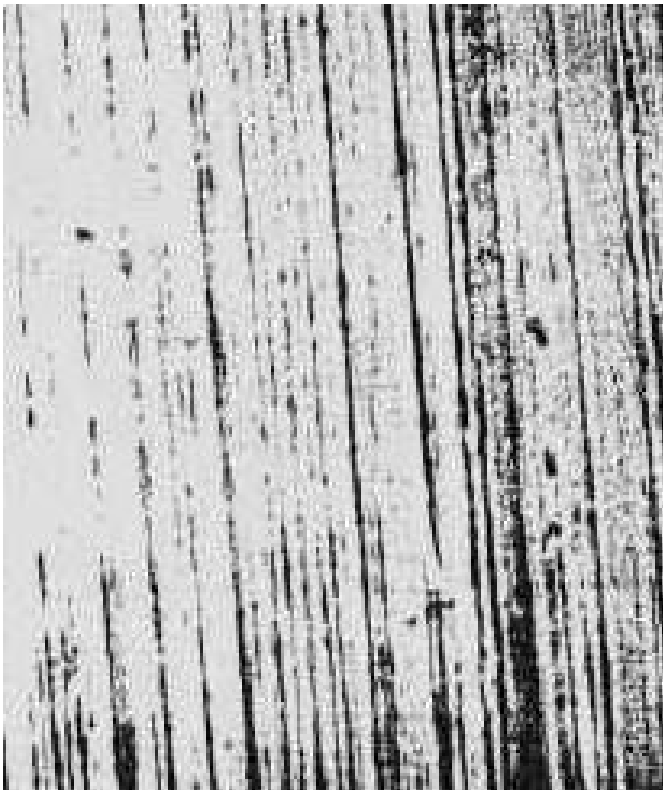
Inner 1 from Untreated Unit (Fig 4)

This photo shows the results of the ball in Fig. 2 skidding across the surface.

This is the classic example of galling of a race by a ball due to inadequate lubrication. Close examination shows that the metal is being 'peeled' as well as scored. Pitting is also occurring.

It was this wear which allowed the impeller to develop the horizontal movement which resulted in the scoring of the inner diameter of the fan tower.
